Manhole Inspection Summary

Manhole # S45QQ_003MH

Insp Date: **5/6/08 11:47 AM**

Location Address: **Saint Lo Dr**

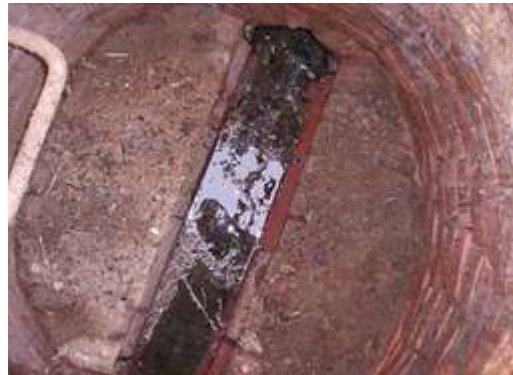
Top View

Frame Offset: **0** (in.) Condition: ☐ Sound ☐ Cracked ☒ **Leaks**

Condition: ☐ Sound ☐ Cracked ☐ Root Intrusion ☐ Loose Brick ☒ **Deteriorated**

Infiltration: ☐ None ☒ **Joint** ☒ **Cracks** ☐ Mortar ☐ Roots ☐ Wall
